CLTP 6 REPORT

Prof.Dr. Omer Soykasap
Afyon Kocatepe University,
Department of Material Science and Engineering
Afyonkarahisar, TURKEY
E-mail: soykasap@aku.edu.tr
Web: www2.aku.edu.tr/~soykasap

24 August-04 September 2015
Organized by UNISEC and Hokkaido University
Sapporo, Japan

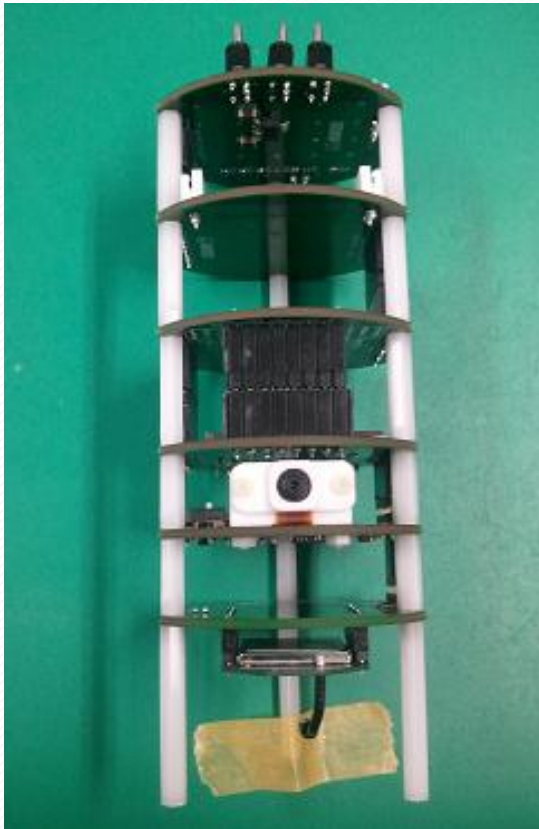
mass=151 g

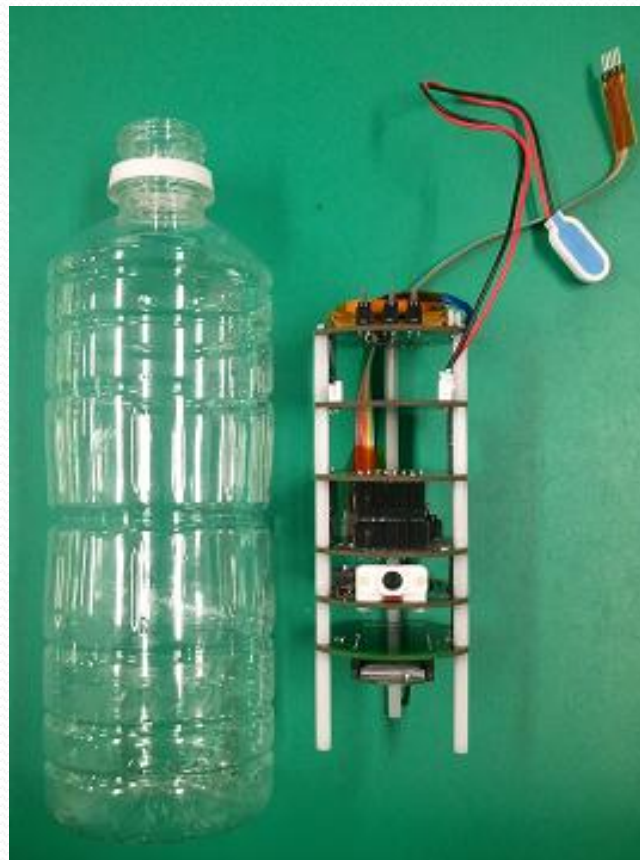
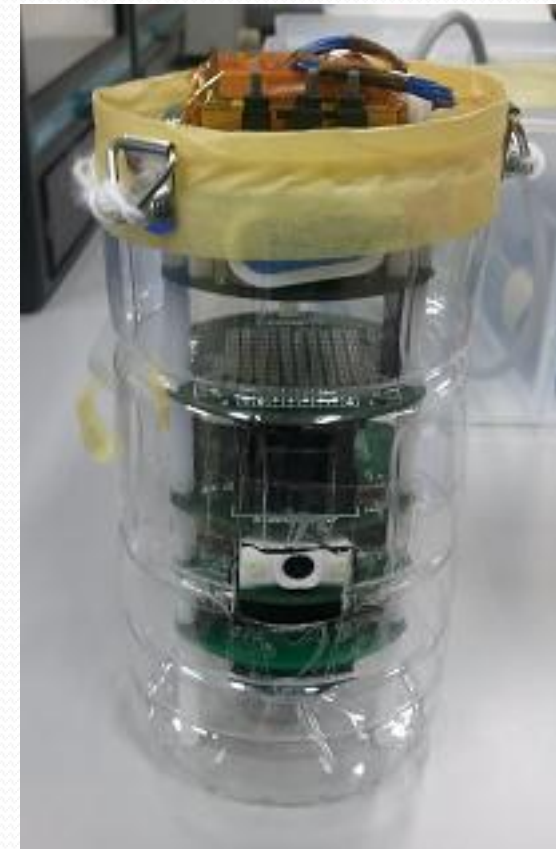
mass=176 g

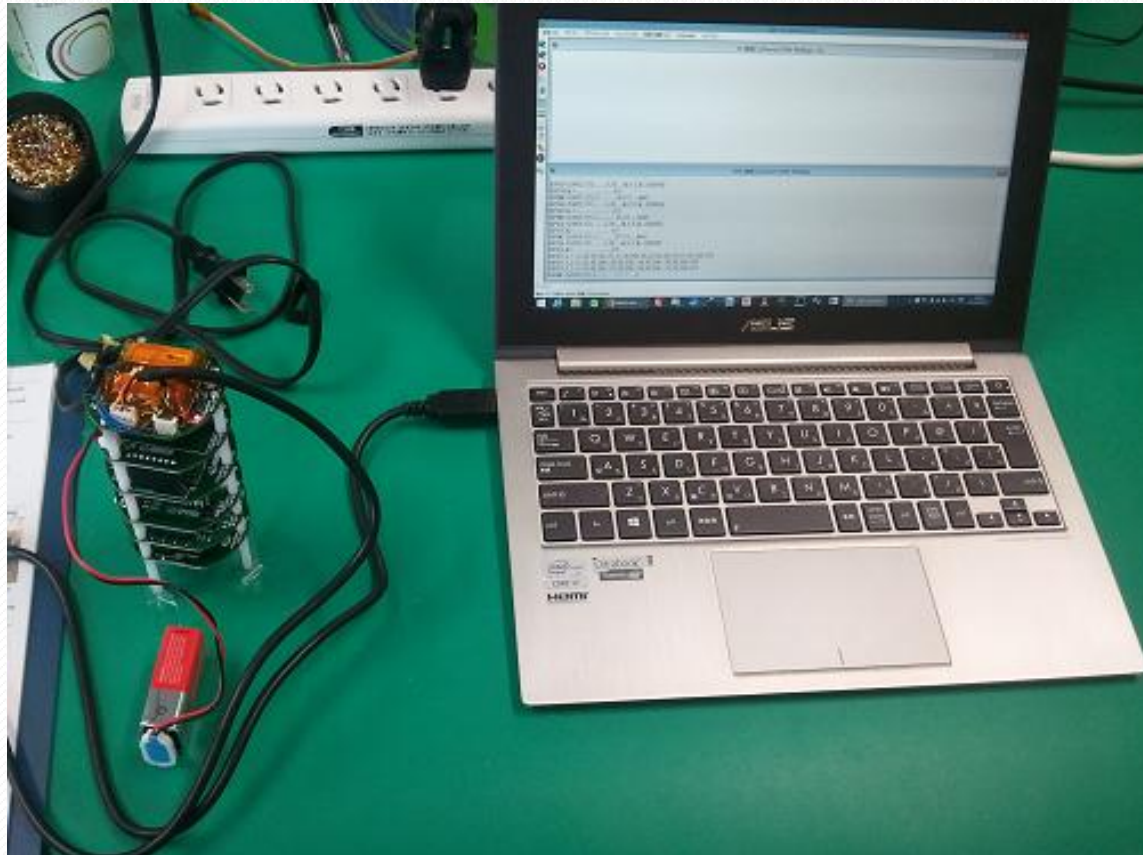
Ground Test: Functional Test

Check GPS and camera

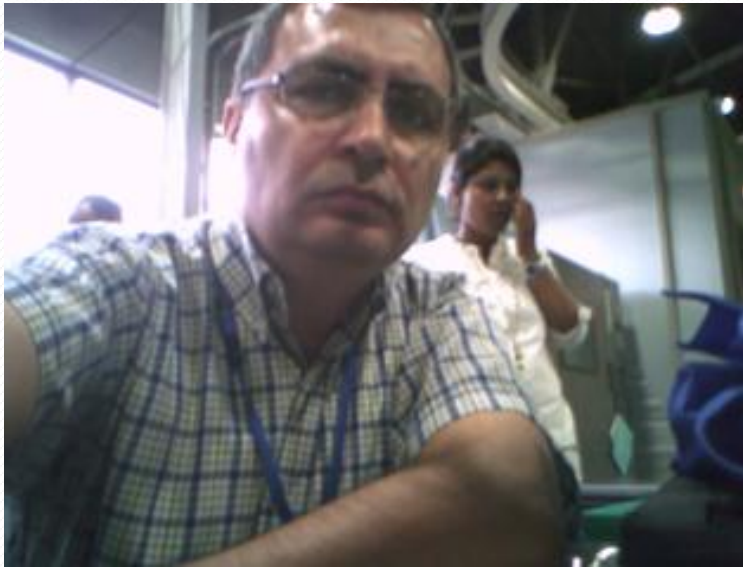
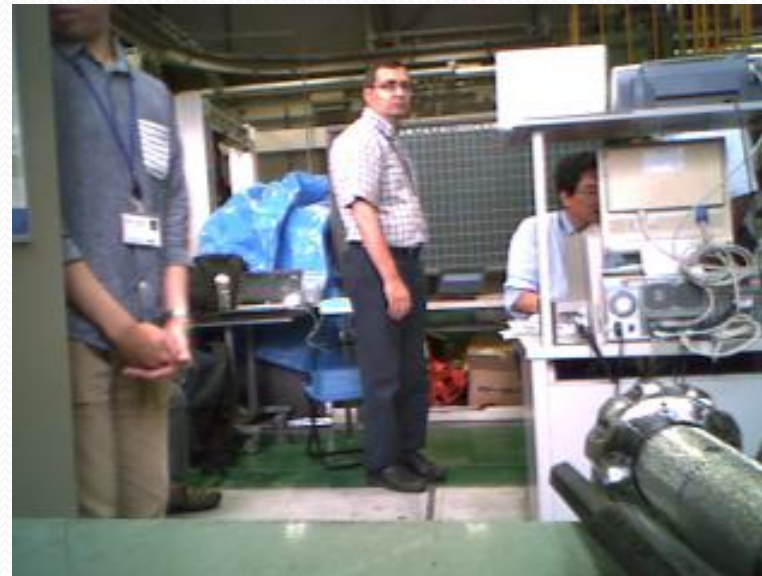
Ground Test: Functional Test

Camera images: camera works well

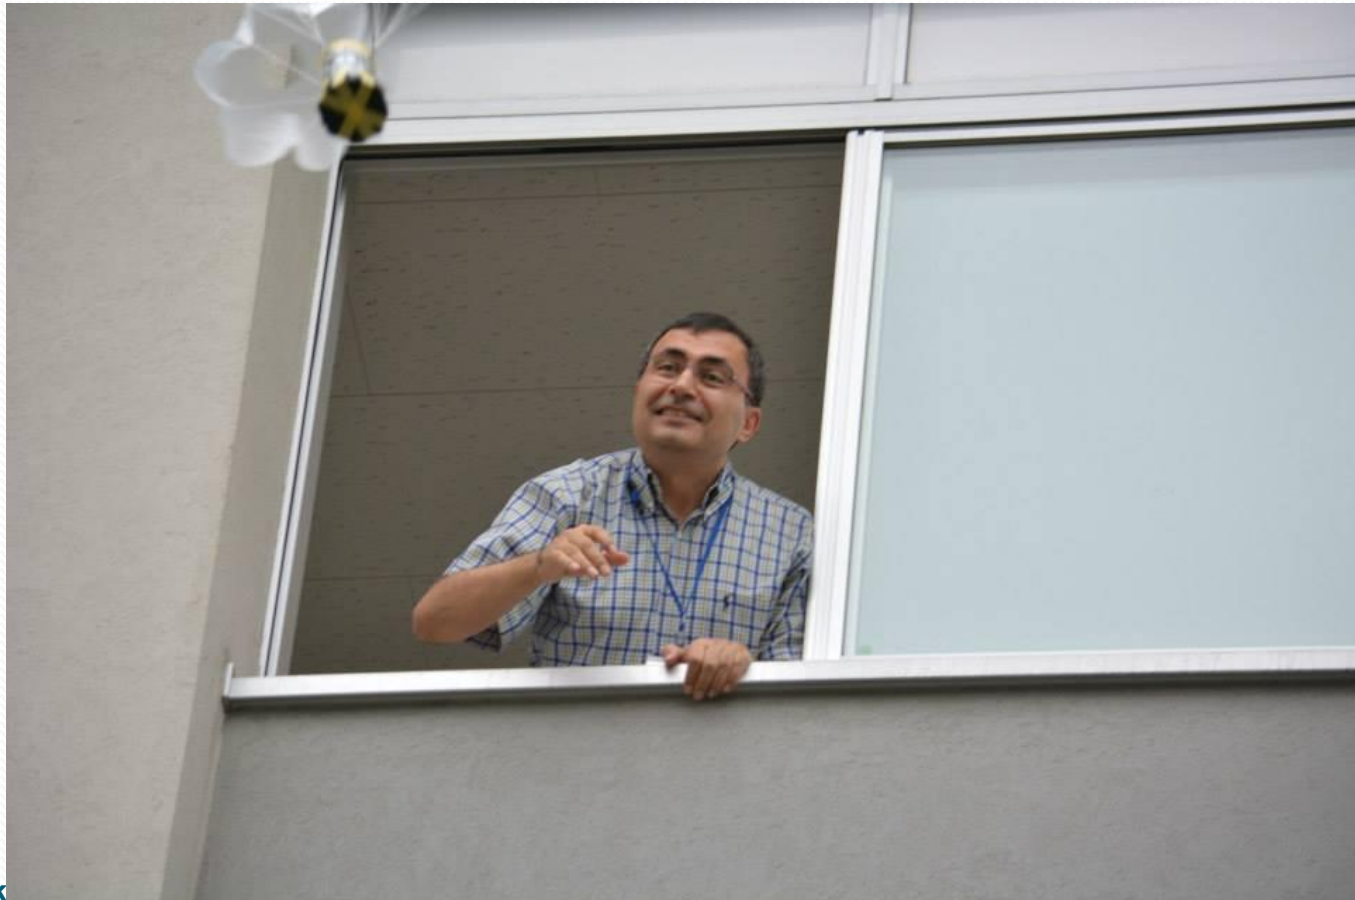
Ground Test: Parachute Test

Carried out to check the parachute and signals during dropping from third floor, no problem appears.

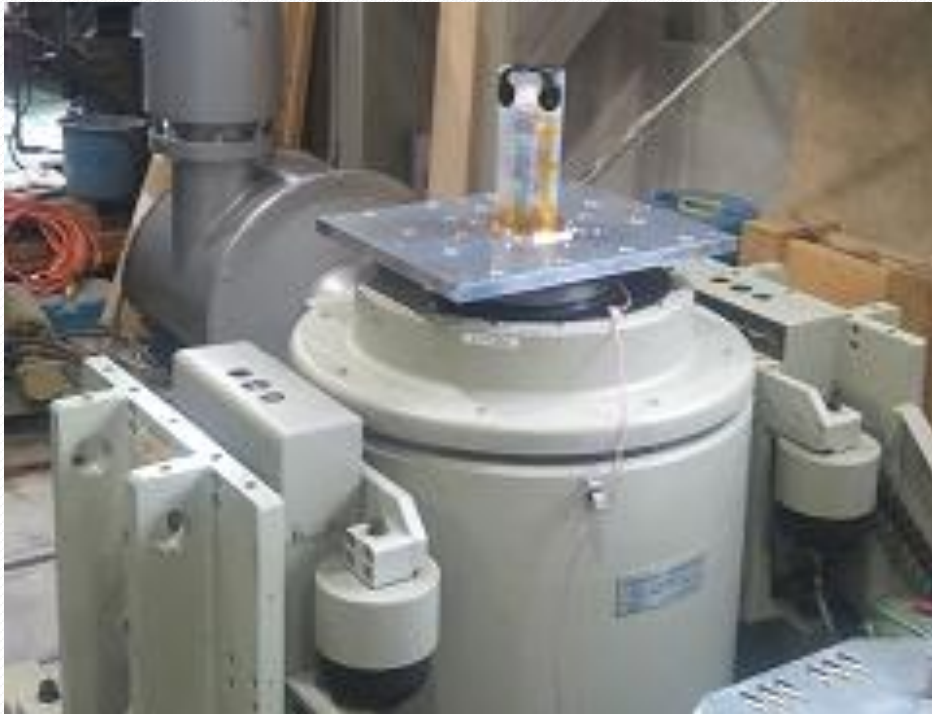
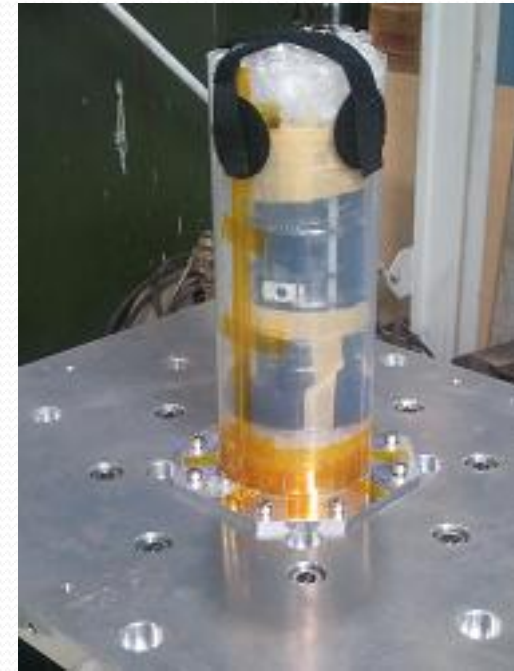
Ground Test: Vibration test

Sine, random and shock tests are carried out along longitudinal direction in a sequence: no problem

Type	Direction	Frequency	Acceleration	Duration
Sine Wave Vibration	Rocket Launch	10 Hz	7.88 G _{0-P}	0.4 s
Random Vibration	Rocket Launch	5 to 2000 Hz	1.42 G _{rms}	7 s
Shock	Rocket Launch	-	8.00 G	2 times

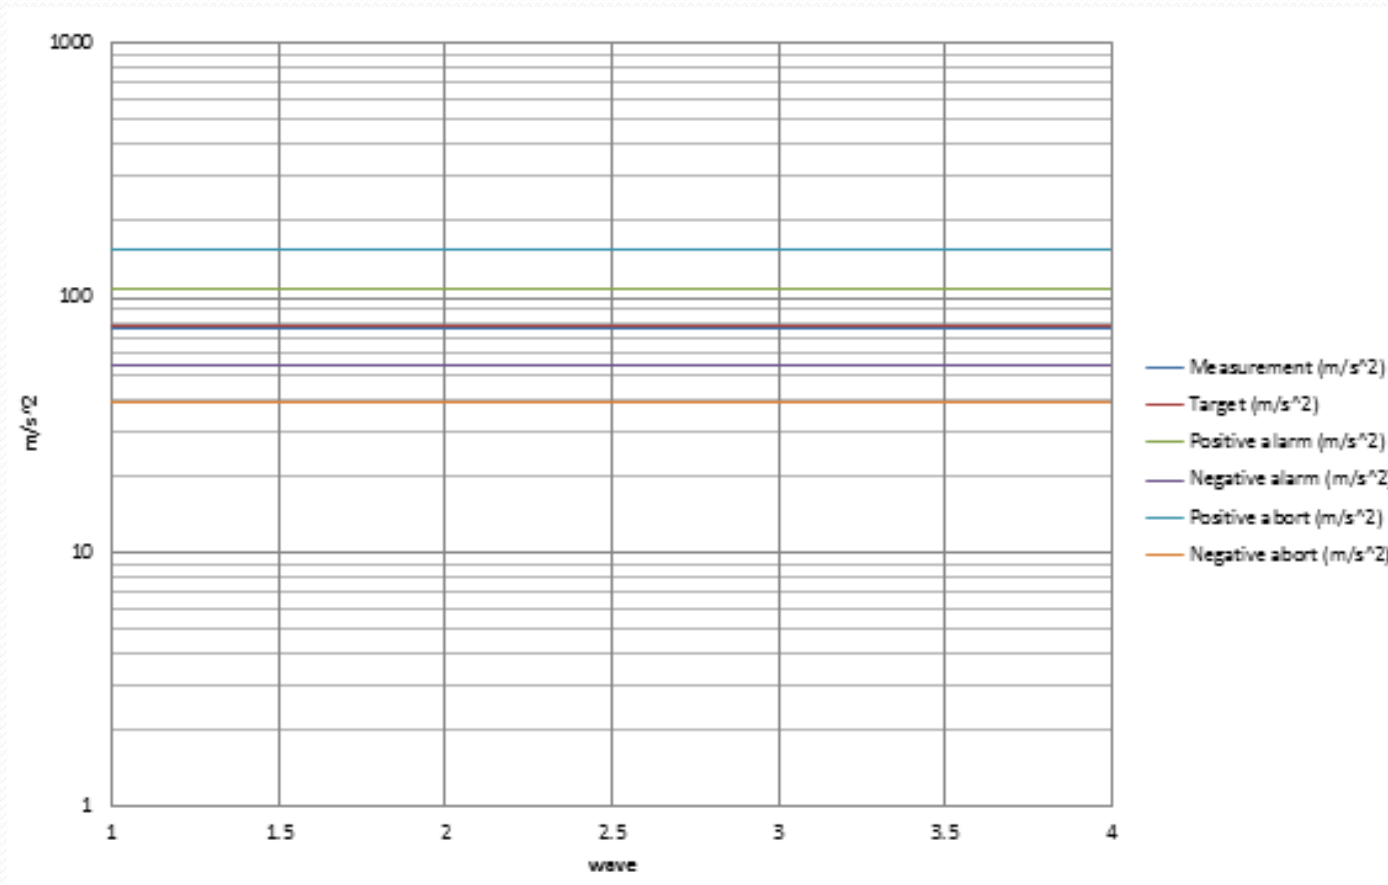
Ground Test: Vibration test

Sine vibration target setting value 77.22 Hz, Measured 77.5 Hz

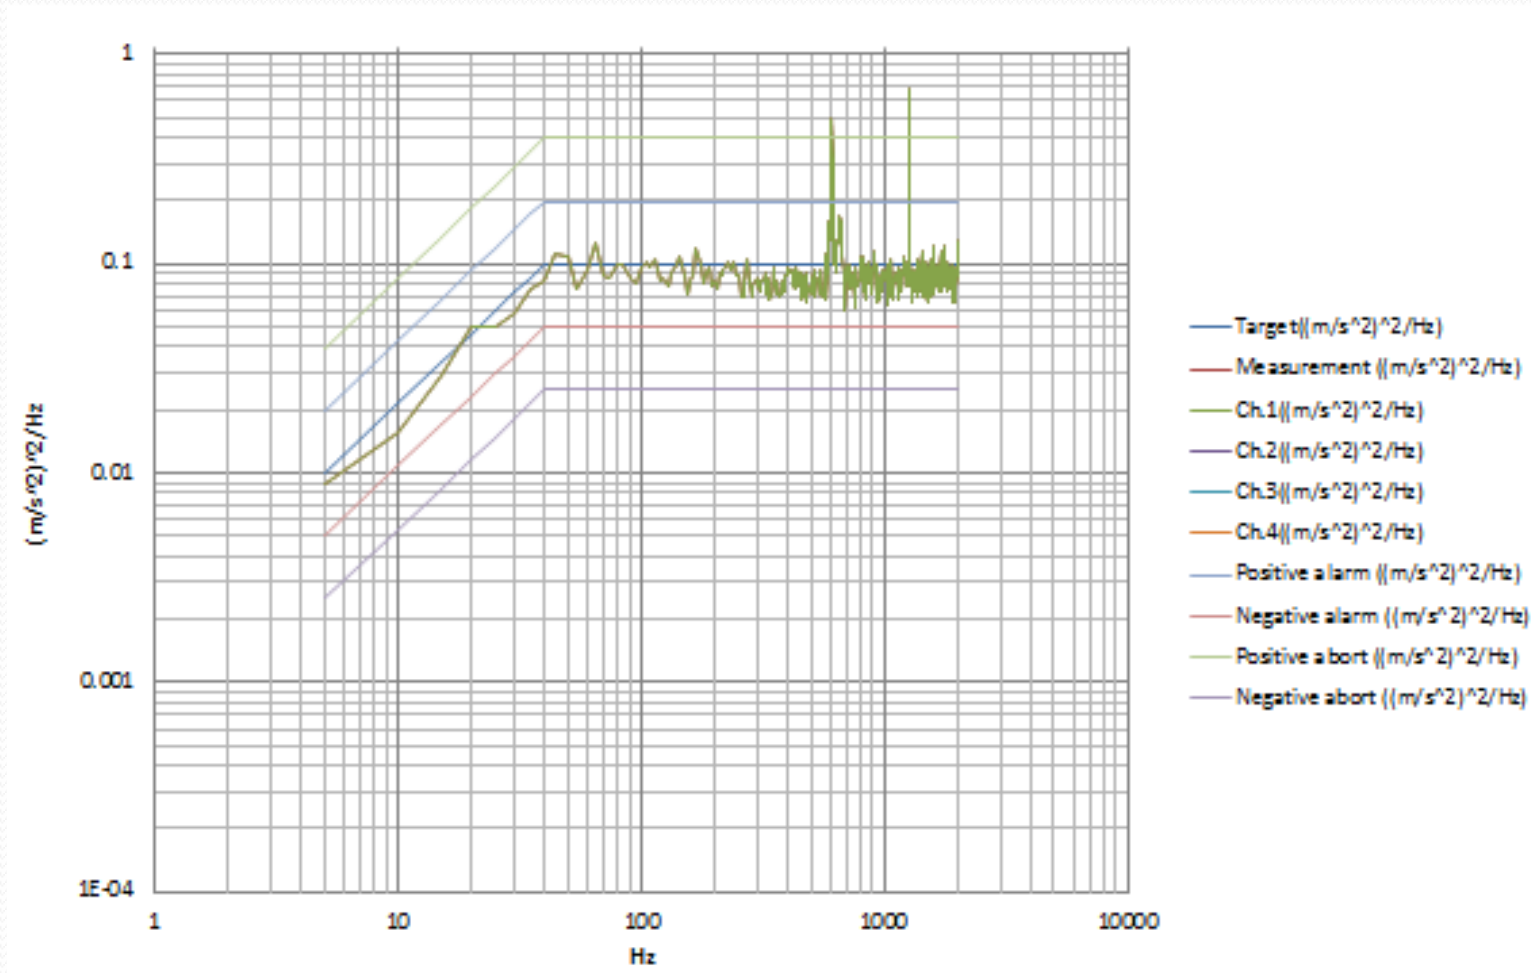
Ground Test: Vibration test

Random vibration: PSD graph

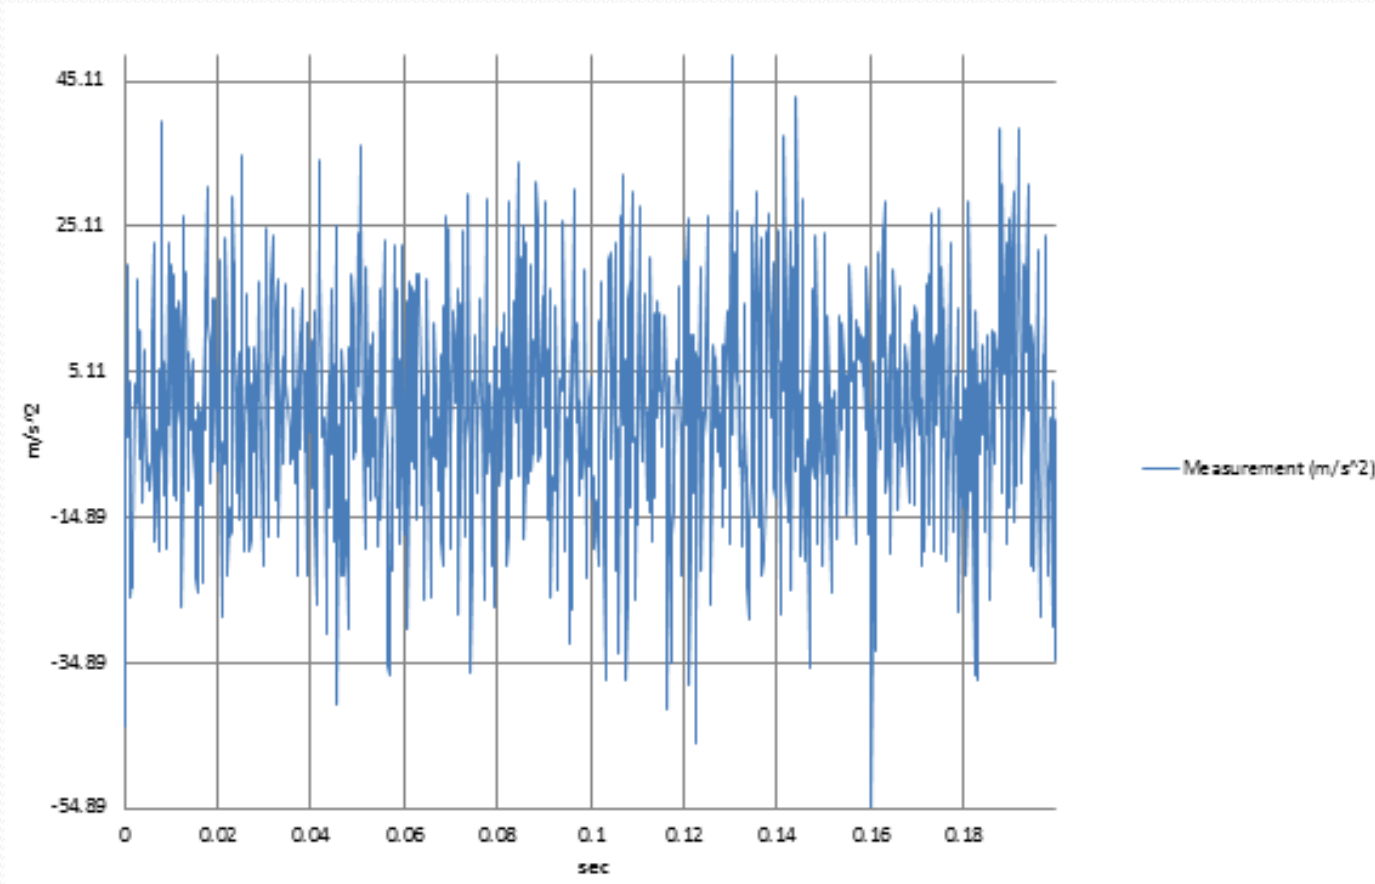
Ground Test: Vibration test

Random vibration: frequency vs. time

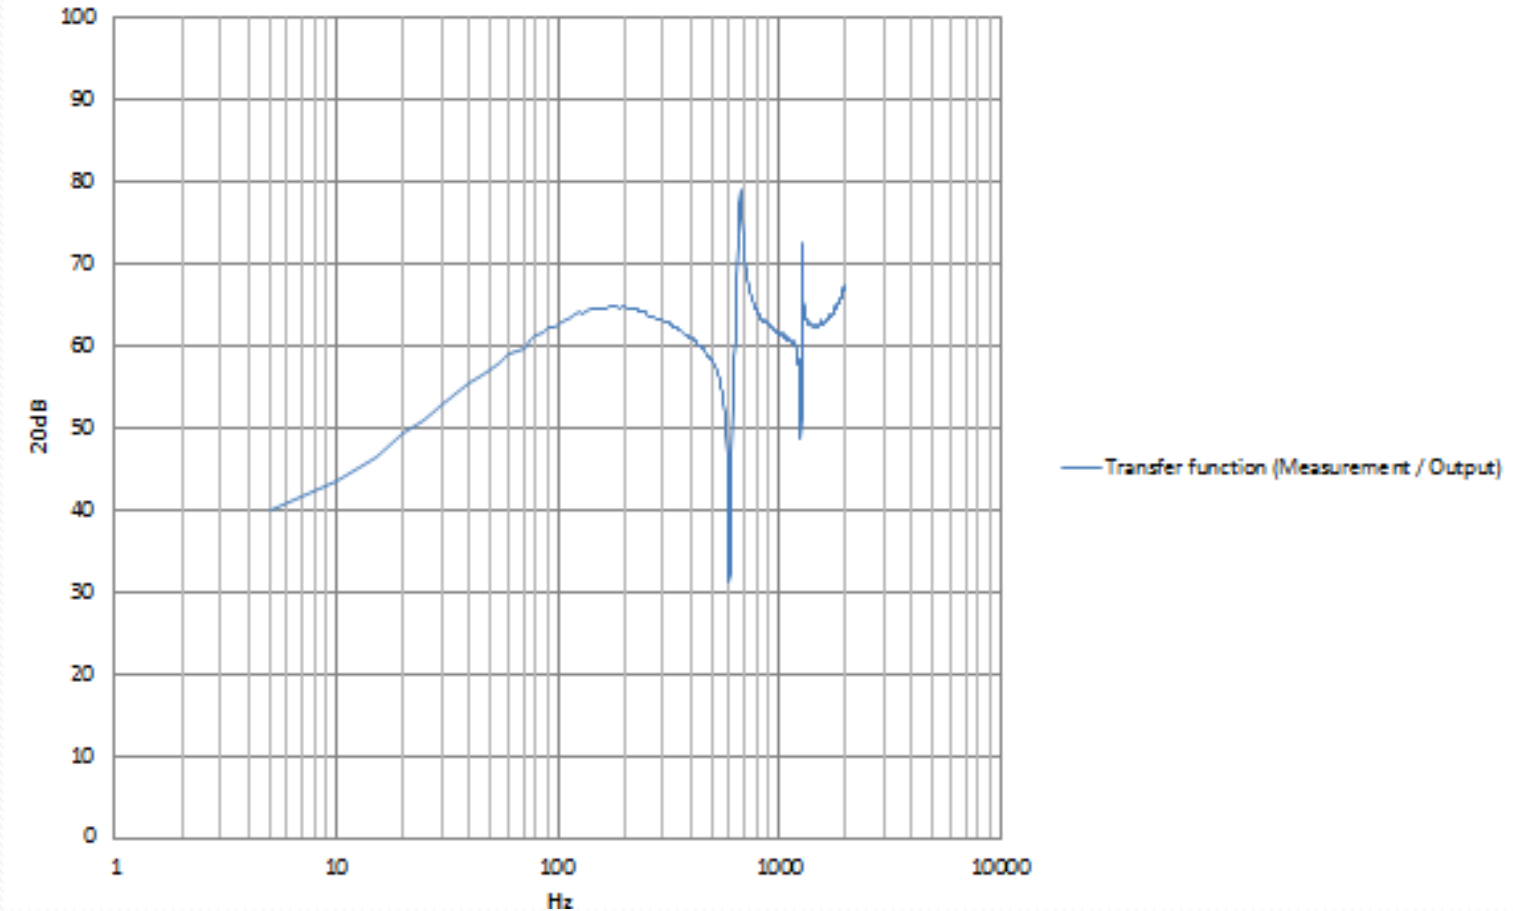
Ground Test: Vibration test

Random vibration: transfer function, first peak 700 Hz above requirement of 100 Hz

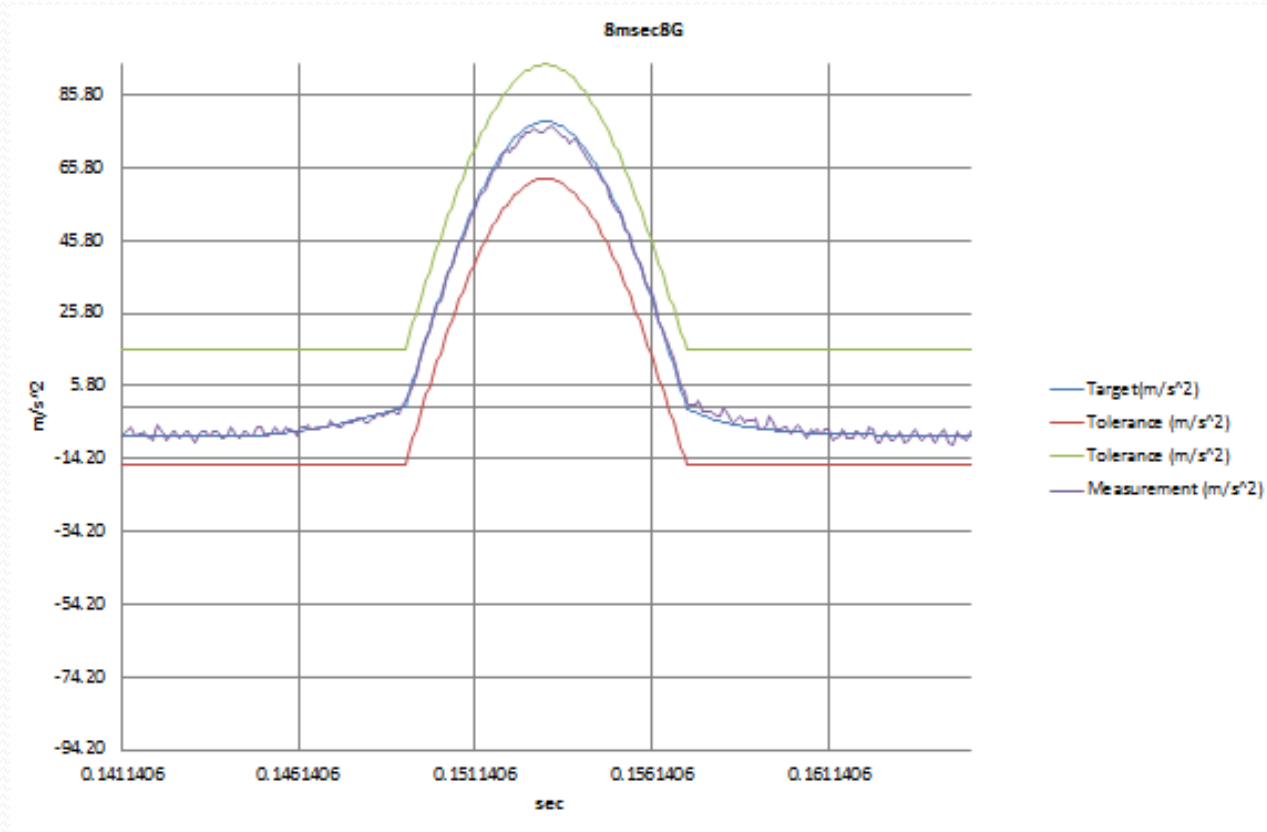
Ground Test: Vibration test

Shock test 1 (8ms, 8G), history of acceleration

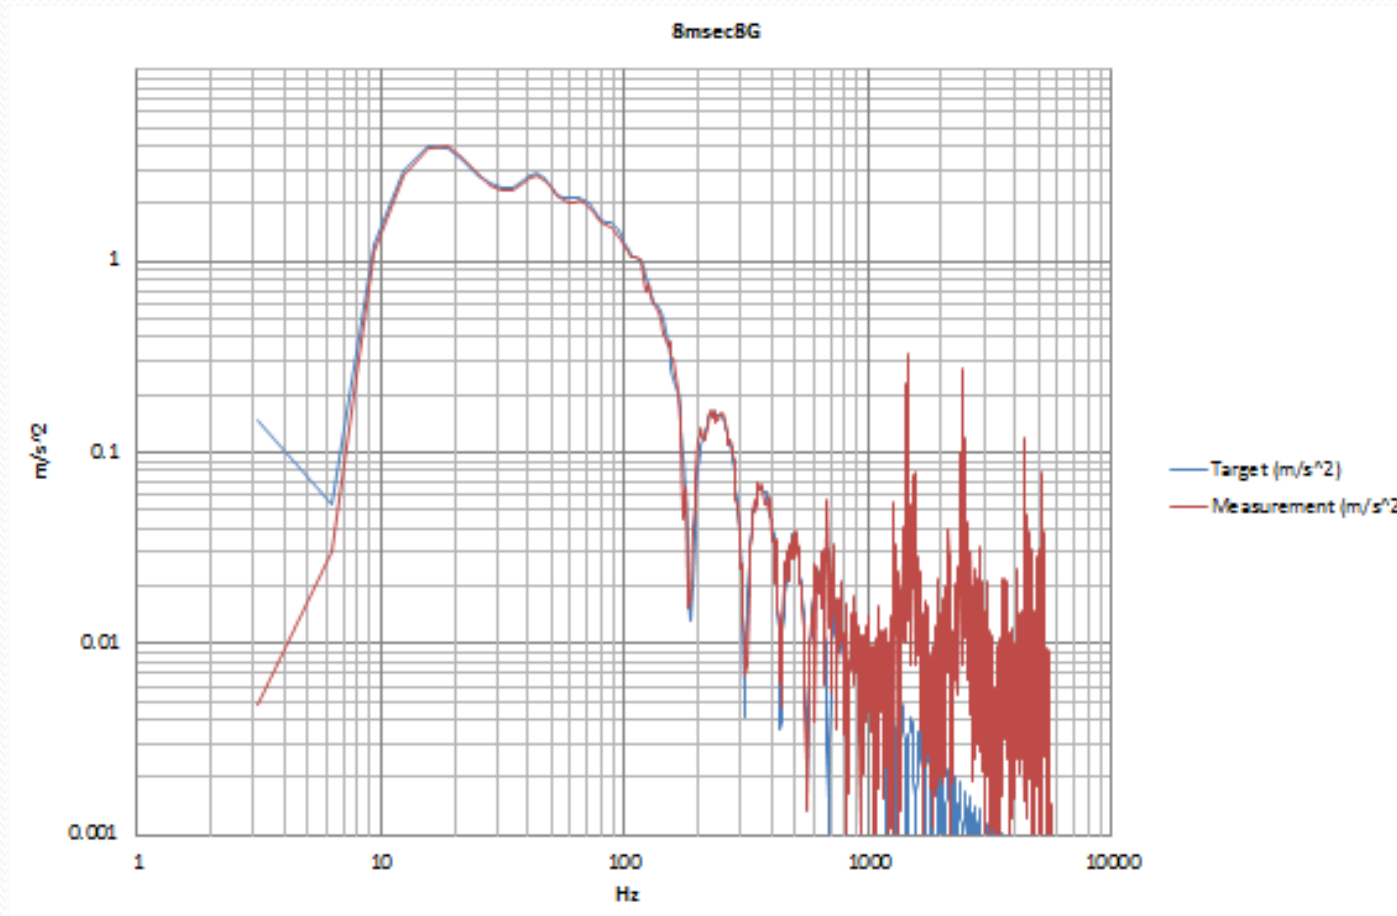
Ground Test: Vibration test

Shock test 1 (8ms, 8G), FFT

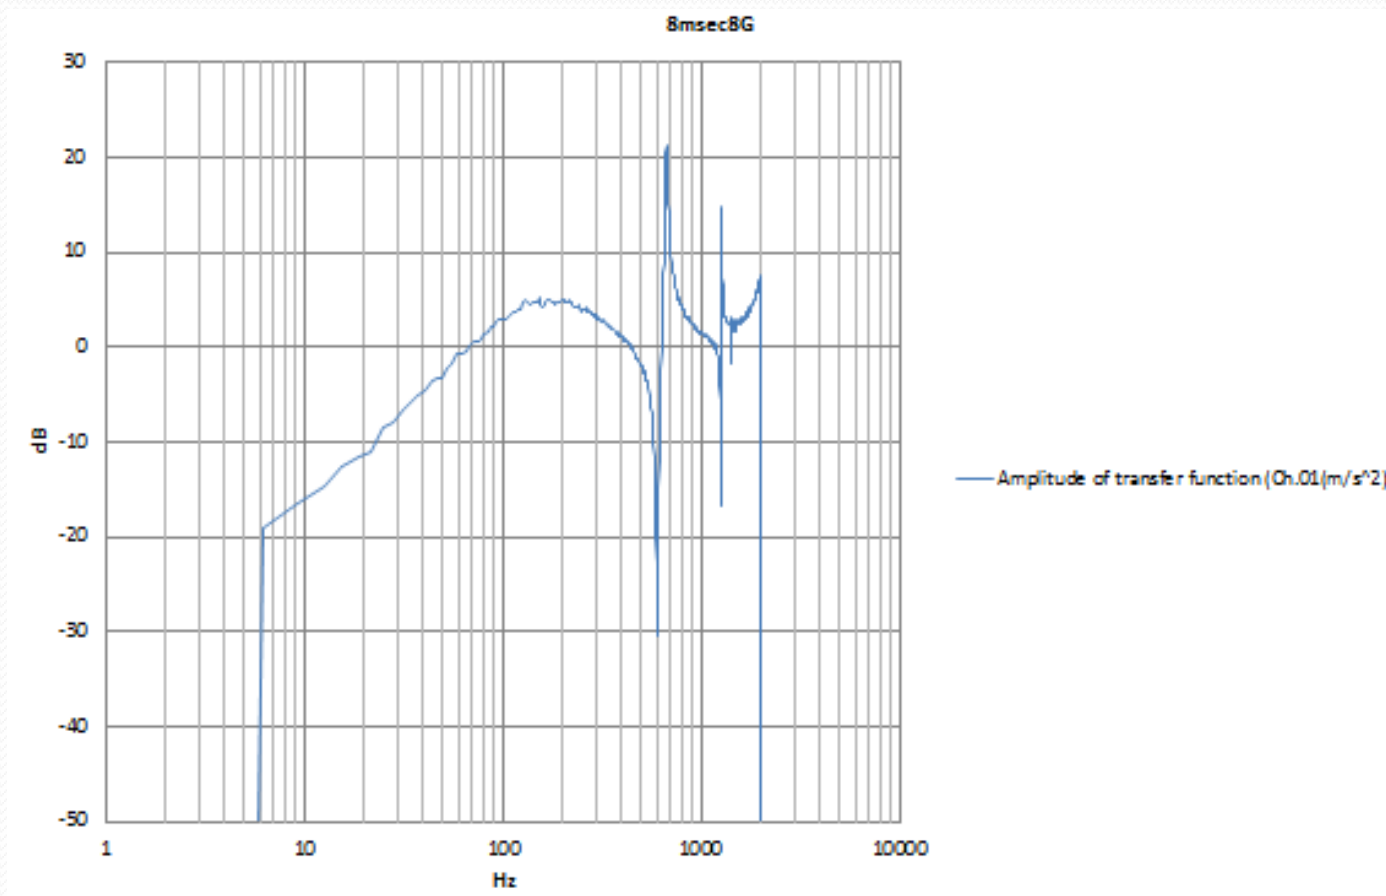
Ground Test: Vibration test

Shock test 1 (8ms, 8G), Transfer function, first peak 700 Hz
above requirement of 100 Hz

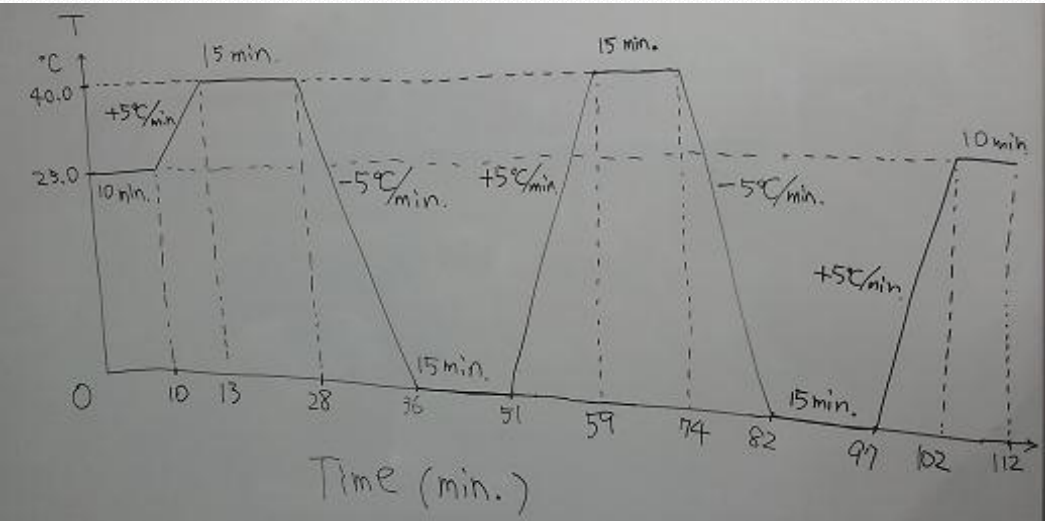
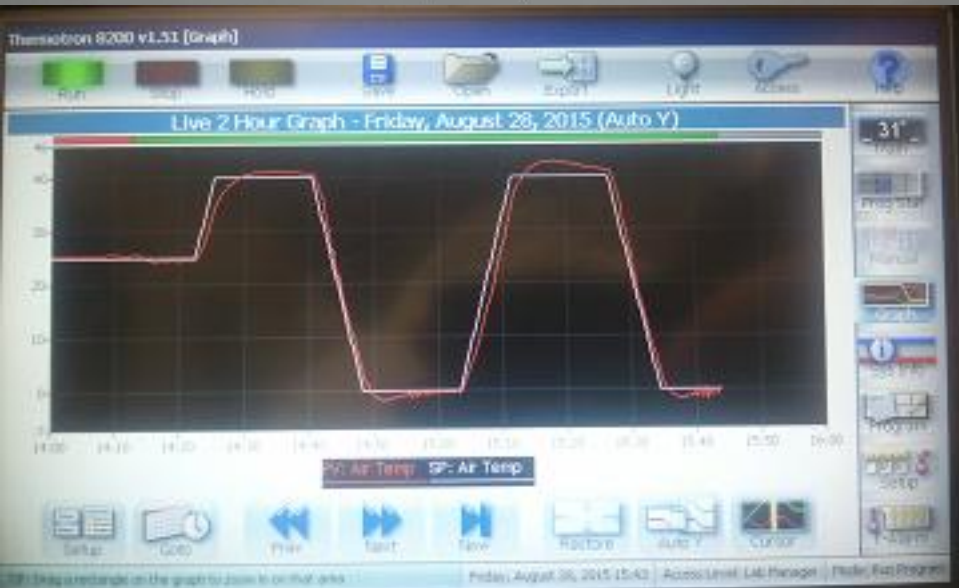
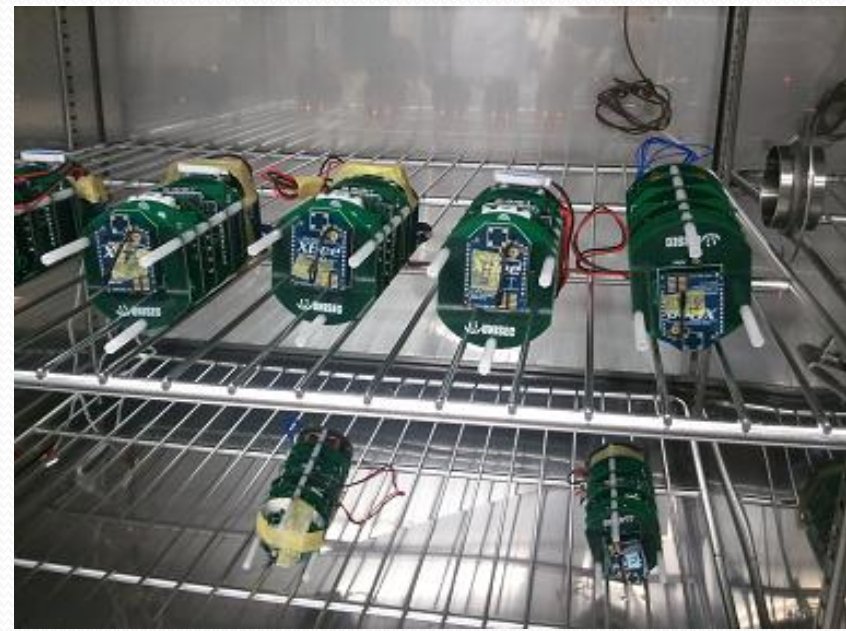
Ground Test: Thermal

Thermal cycle: 0-40 °C,
112 min,

Stops transmitting GPS
after 1 hour due to
battery life

No problem after testing

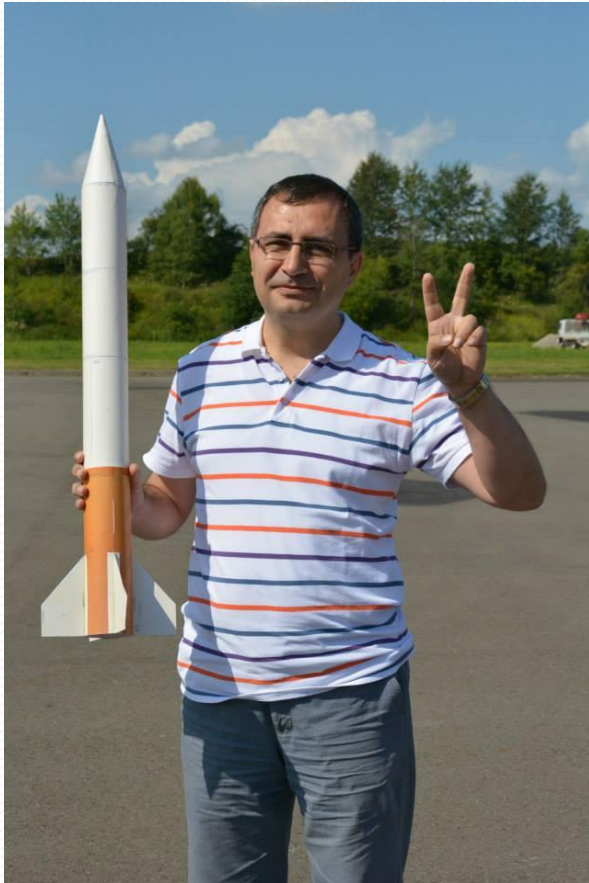
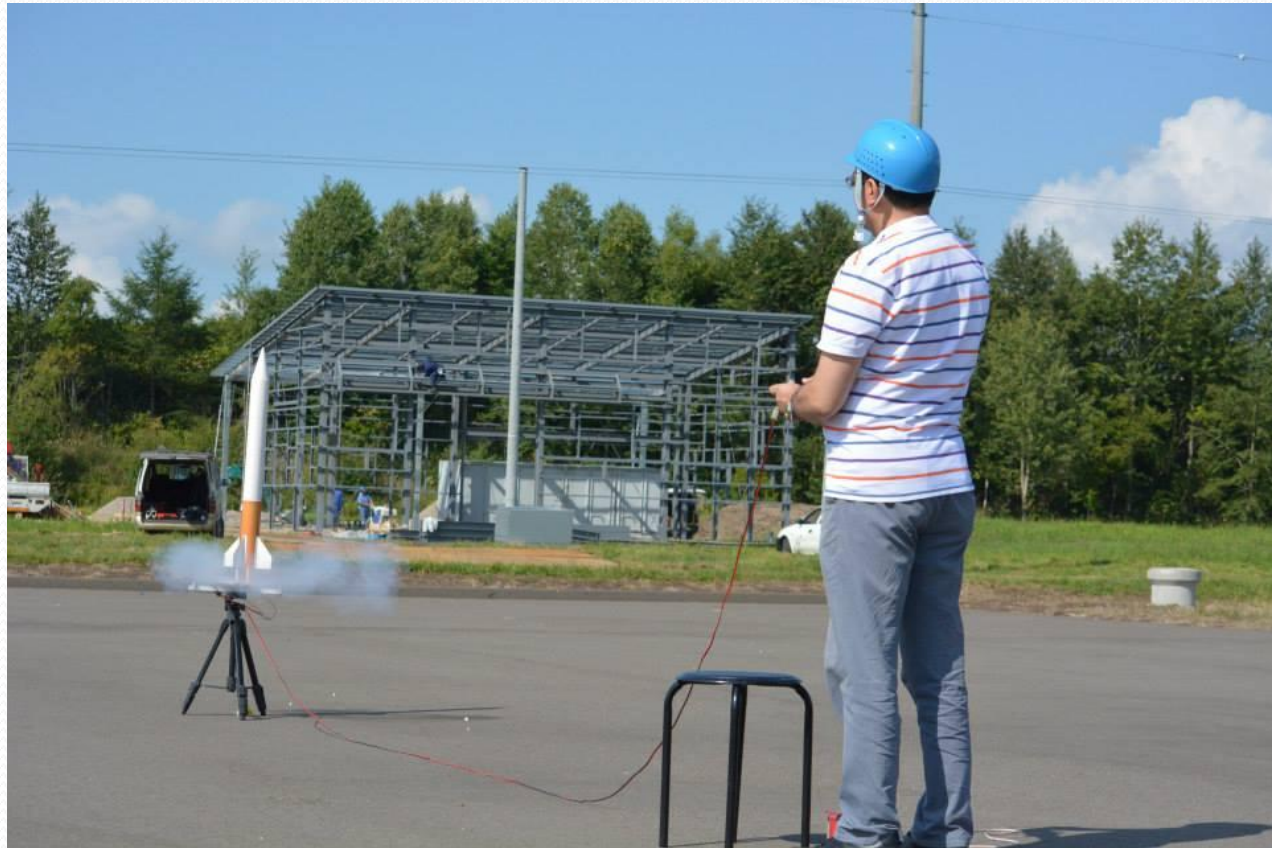
Launch 1&2

Successful launch, but ?

- Successful launch and separation of first stage,
 - Launch 1, second stage separation is failed and the CanSat crashed to the ground, resulting a damage in camera and X-bee transmitter.
 - After failure the reasons are investigated for failure: First launch is failed due to strings of parachute stuck in the second stage of rocket
 - Launch 2 a) Attach the strings of parachute via grommet holes on the plastic container so that the CanSat is separated in the second stage b) Put the CanSat upside down in the rocket
 - Launch 2 failed after the first due to the forward movement of the CanSat in the second stage. But this time it was soft landing. It was decided some improvements in the rocket are needed for separation in the second stage

- CanSat successfully assembled, and tested on ground for functional tests, vibration, thermal and parachute opening.
- First and second launch are failed due to strings of parachute stuck in and forward movement of the CanSat the second stage of rocket.
- Damaged parts are replaced and lesson learnt applies to the CanSat. Final launch resulted in a success.
- It was a great experience, and beyond my expectations. The CanSat Leader Training Program (CLTP) enabled me to have an experience the entire cycle of CanSat development from the design to launch as well as teaching methods utilized in space engineering.

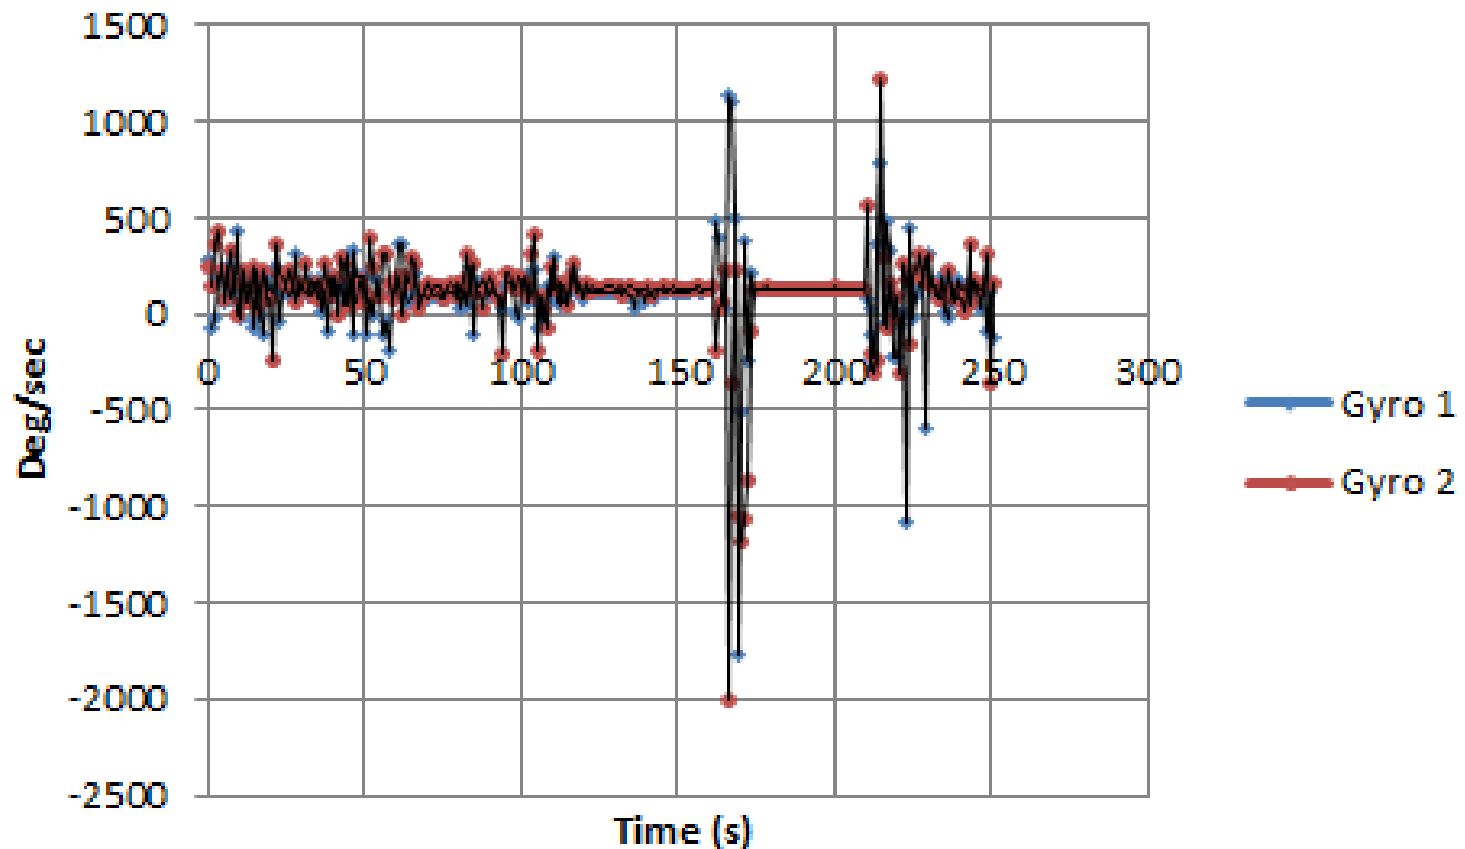
Launch 3

- Gyro readings

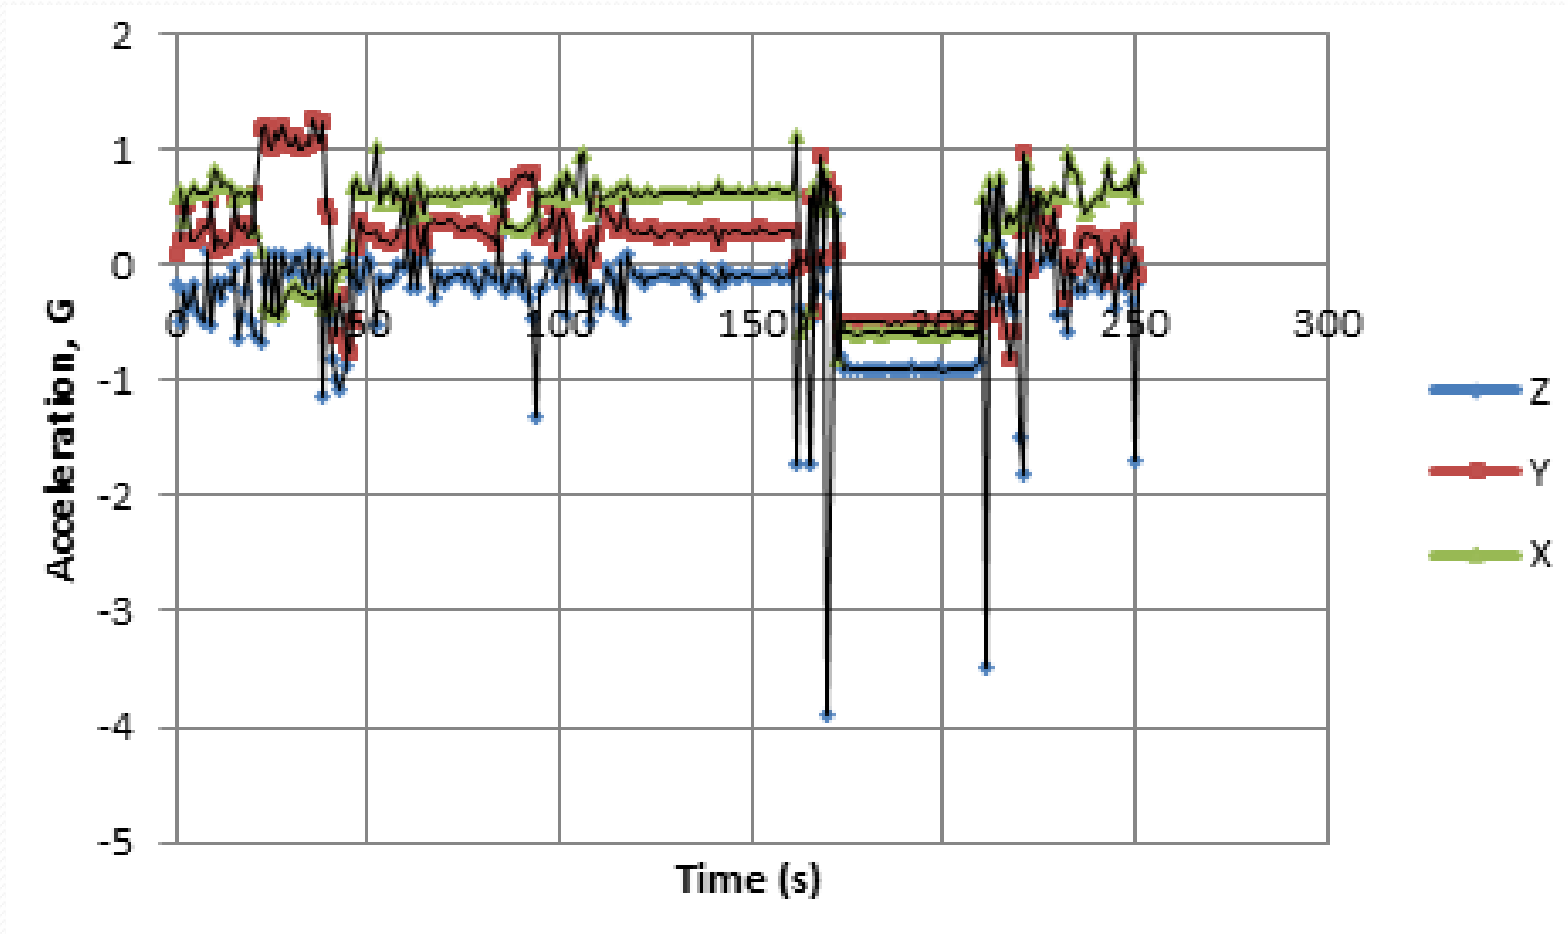
Launch 3

- Acceleration reading
